THE MARINE INDUSTRY

Ship owners James Fishers contacted Metalock Engineering UK to see if a repair was possible on their main engine bedplate.

Engine type: WH Allen – type6 BCS 37 Delta

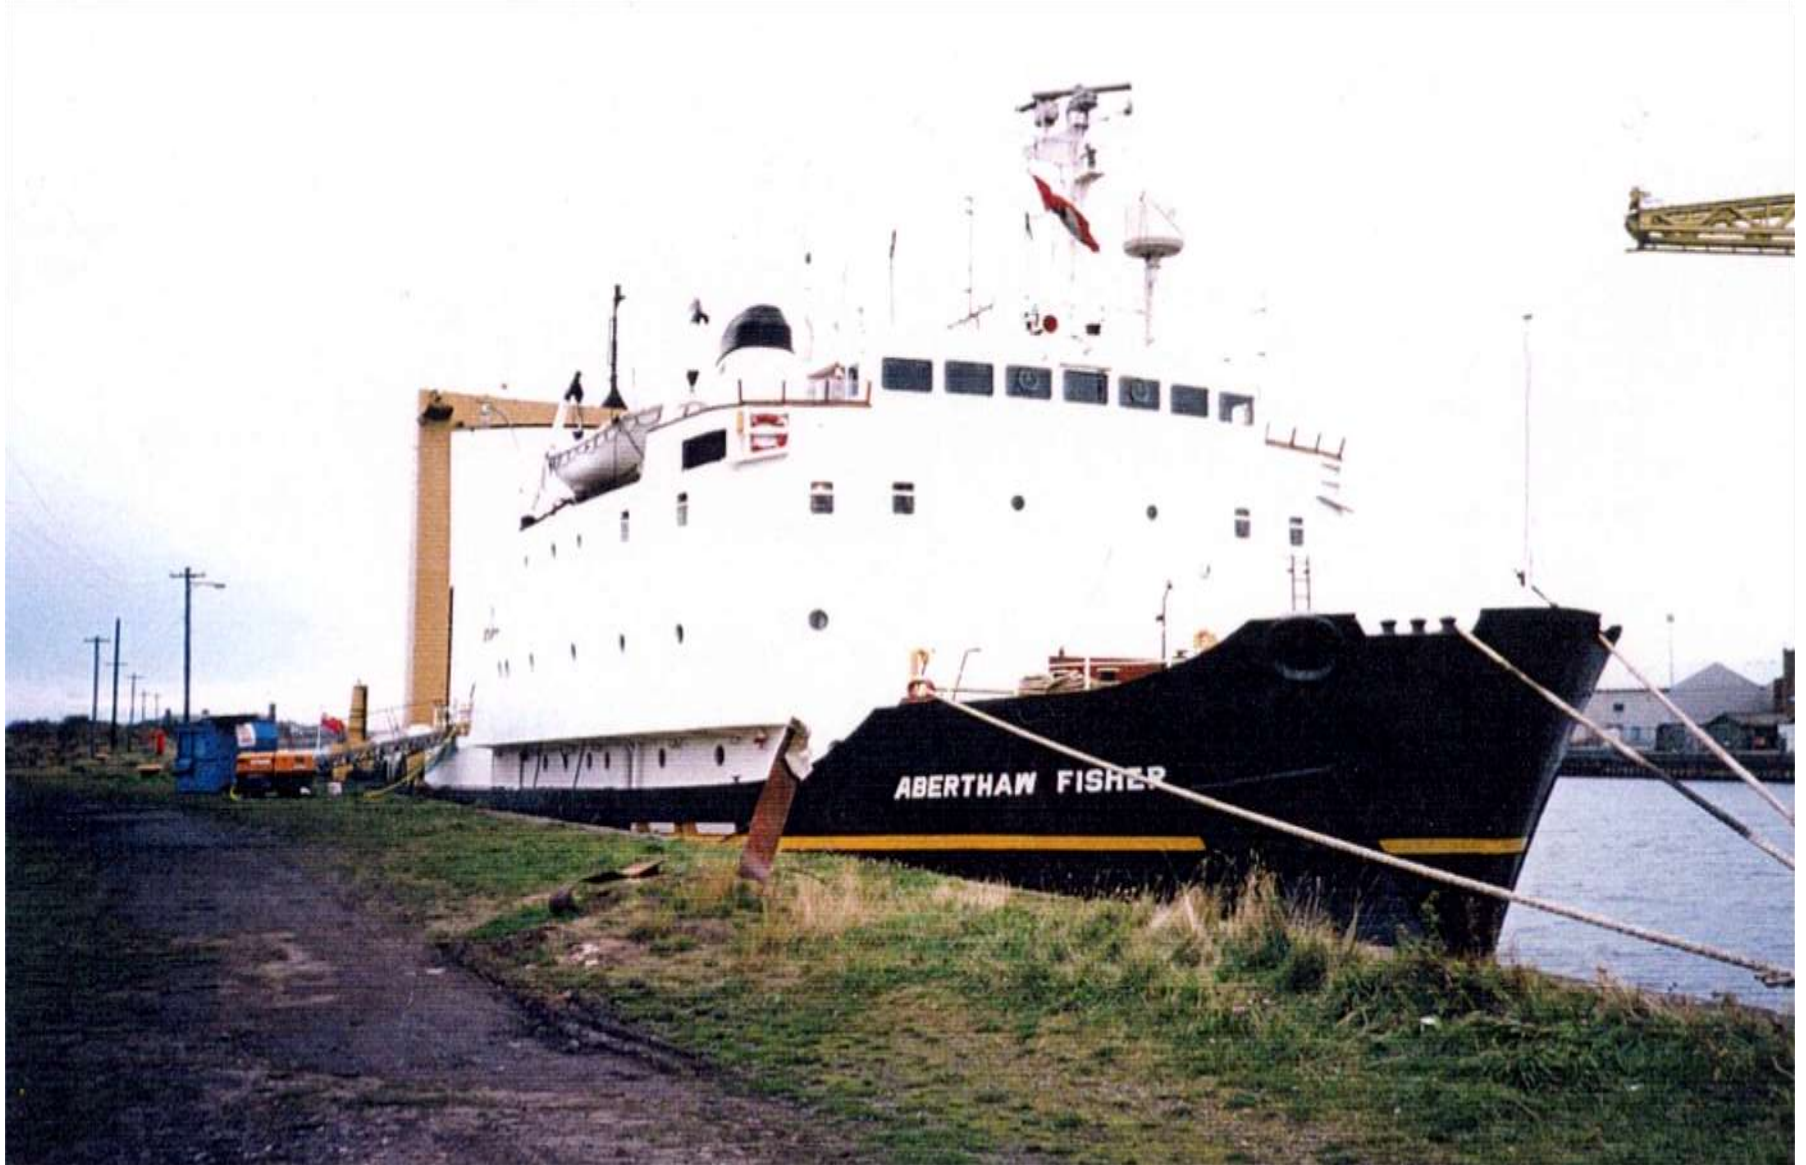
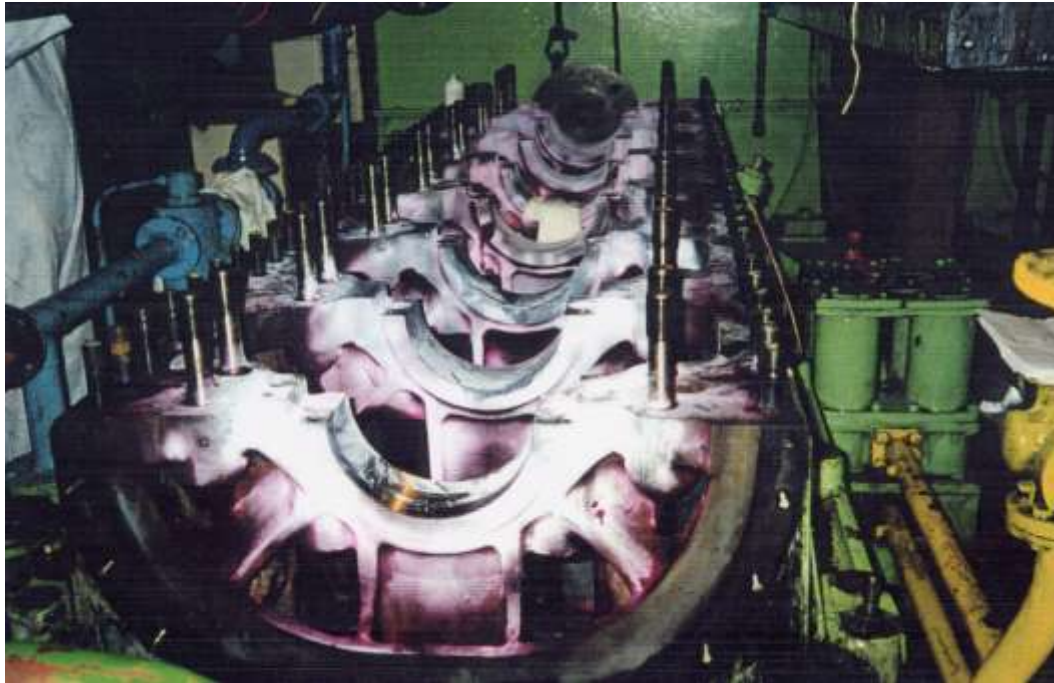
After a routine inspection cracks were found to both sides of the No.4 main bearing pocket, these were thought to have been caused by fretting of the bearing cap due to insufficient tightening of the bearing cap nuts.

Overall views of the main engine bedplate

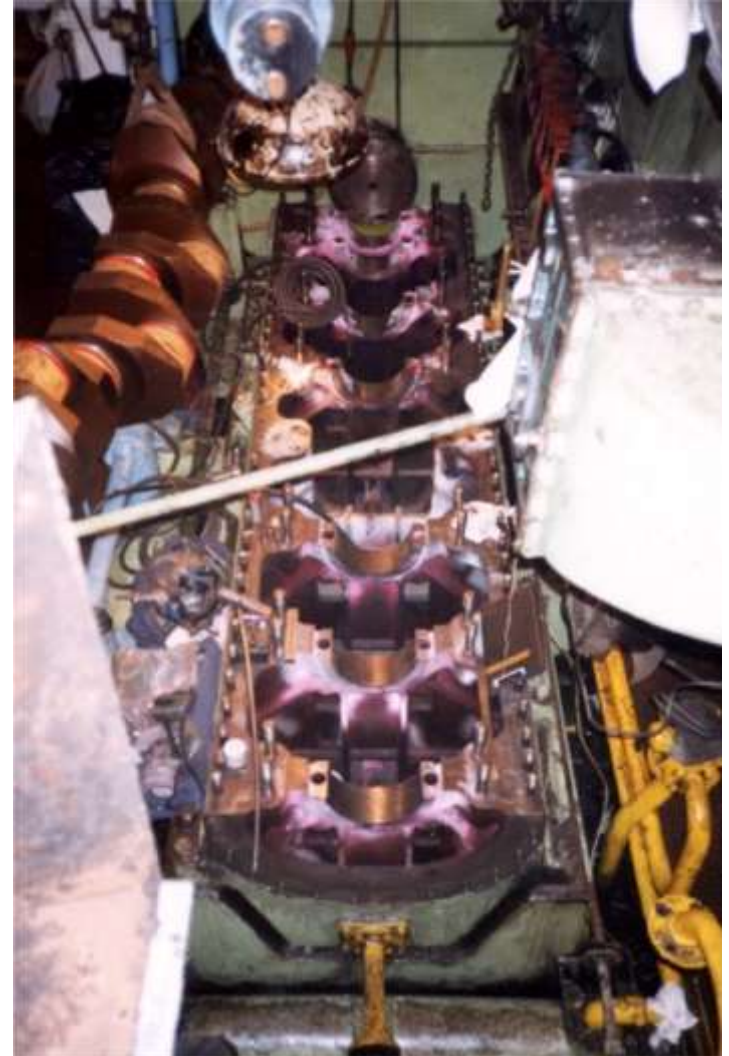
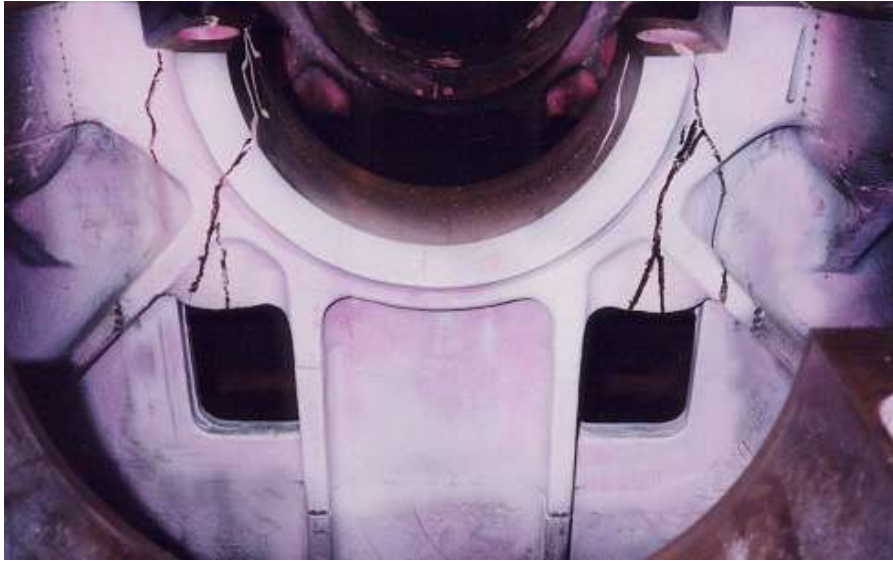
Bearing pockets highlighting cracks

**Area of cracking to thin
to repair, suggest
bearing transplant**

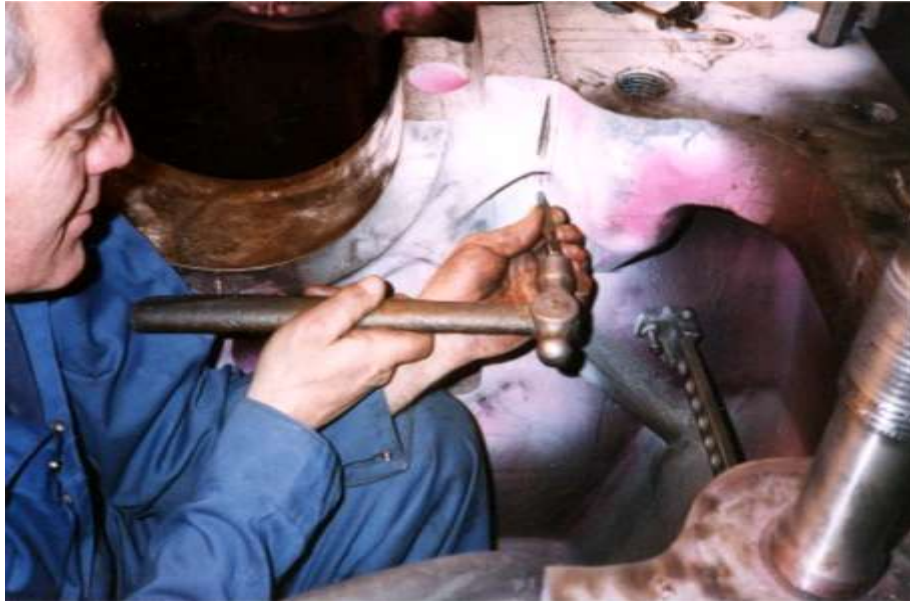
**Technician marks out area
for removal**

**A repair was designed with
the customers approval and
the technicians were
dispatched to site**
