Summary of Inspection

Date: 11-10-2007

Report No. 071011.3348

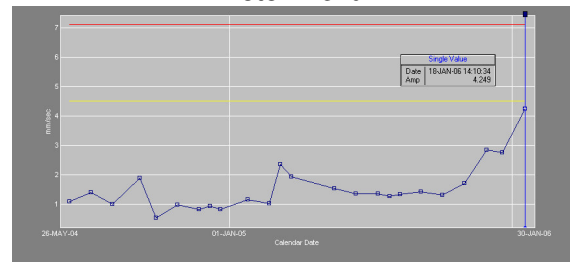
2 01
Motor Trend

We previously reported the motor had shown an increase within the high frequency band, due to electrical fault frequencies.

These fault frequencies are still present and have increased further. This is due to a progression of the electrical fault. (See motor trend 2 02).

Inspect all the electrical connections to the motor.

I would recommend particular attention is paid to the yellow phase fuse connection, this is also illustrated on page 15 of your Thermographic report.

If this work has been carried out, there will be a fault on the motor.

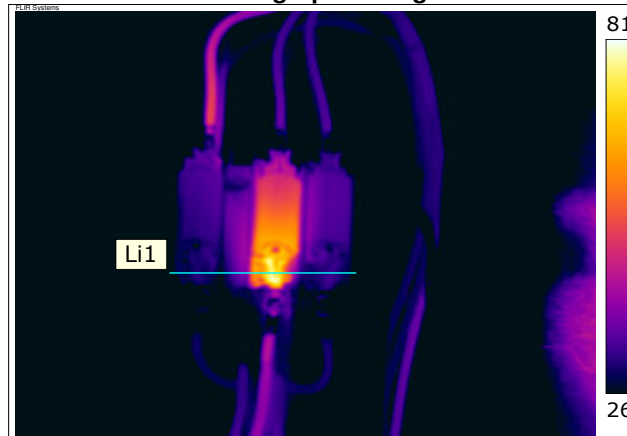
Thermographic Image

The Thermographic survey has shown a hot spot on the supply to this motor. See Thermographic image opposite.

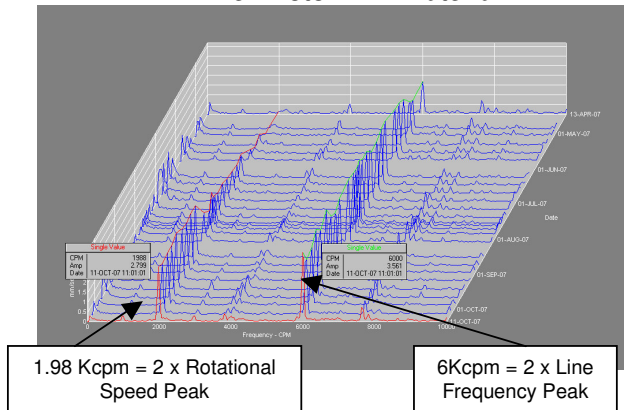
1A.1 Vel. Motor NDE Waterfall

The previously reported 6Kcpm peak (2 x Line Frequency) is still evident in the axial plane. As previously reported, there is now an apparent and progressive increase in the 2 x rotational speed frequency level. (See Waterfalls 1A.1 & 2A.1).

The increase in the 2 x rotational speed peak is indicative of an ongoing increasing 'mechanical movement' in the axial plane and a recent increase in the vertical plane.

It is assessed Axial looseness is related to the 6 Kcpm axial peak and therefore rotor related.

As a first action check, confirm the security of the bearing cap bolts. Resurvey on completion.

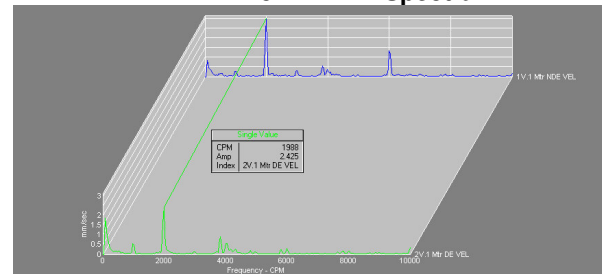
1V.1 NDE & 2V.1 DE Spectra

There has also been an increase in the 2 x rotational speed peak in the vertical plane. (See 1V.1 & 2V.1 spectra overlay)

The vertical looseness may be attributable to the recent bearing change. Bearings themselves do not appear to have 'internal' looseness but may be loose within the housings / between inner race and shaft.

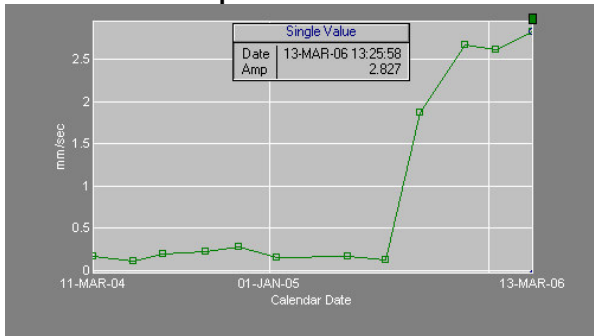
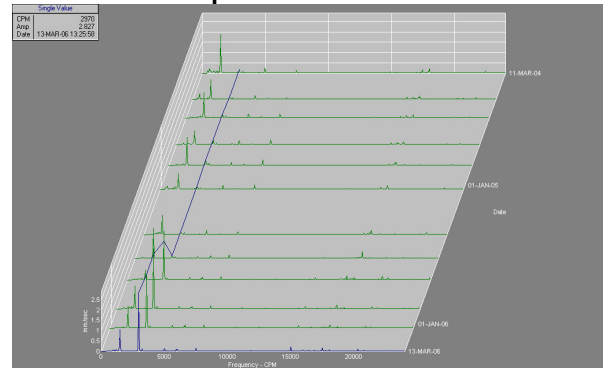
The previously reported increased 1x motor rpm vibration is still present. (See motor 2940 rpm extracted trend and spectrum waterfall 2 04 of 1x motor rpm (2940rpm) increase). This will be due to any of the following:

- Misalignment of the drives. This is possible when there is increased tolerances on the flange spigots.
- Eccentricity of the motor shaft, after motor failure.
- Bent motor shaft, after motor failure.
- Loose gear fit.

Any, or all of the above can cause this unit to fail prematurely and without warning.

We previously recommended you find out why the motor had failed and what repairs have been carried out on the motor. This information can then be used to help diagnose the cause of the increased 1x motor rpm vibration.

Due to the further increases, I would recommend this request is carried out as soon as possible.

Please advise us of your findings. We will then advise what corrective action is required.

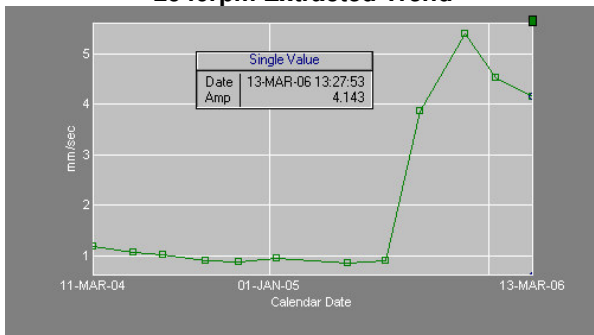
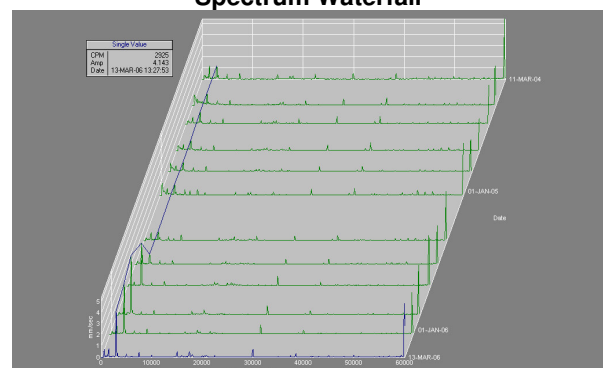
The air end male flute non-drive end increases due to transmitted vibration from the motor shaft speed are also still present. (See air end extracted trend and spectrum waterfall 5 01).

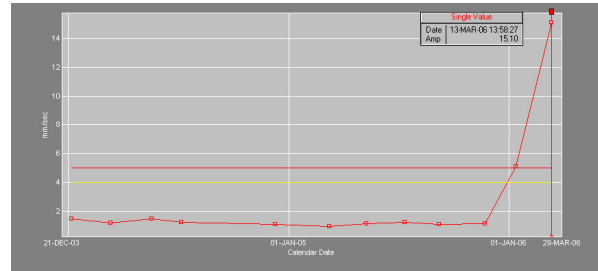
1 01 Motor Looseness Trend

The motor and the input shaft of the air end have both shown increases due to looseness/movement fault frequencies.

This can be caused by either looseness/wear on the motor, or gear shaft assembly. (See motor trend 1 01 and air end trend 5 01).

Remove the motor for repair. When the motor is removed check the air end input shaft for wear/movement.

As this motor was only overhauled in April 2005 and we have been reporting high readings since it was fitted. I would recommend the reason for the failure and all the motor tolerances are closely investigated.

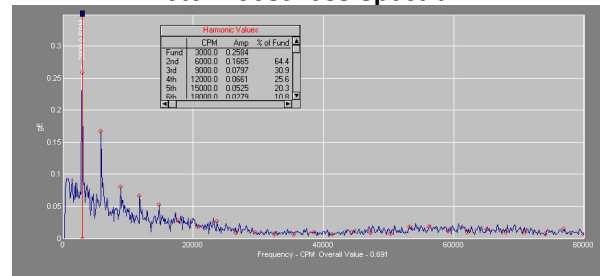
2 02
Motor Looseness Spectrum

As previously reported, the bearing readings on this unit remain at an unacceptable level, due to looseness fault frequencies (See motor spectrum 2 02).

The looseness fault frequencies on this unit are a concern and will be due to either worn housings or journals, I would therefore recommend this unit is removed for overhaul as soon as your production will allow.

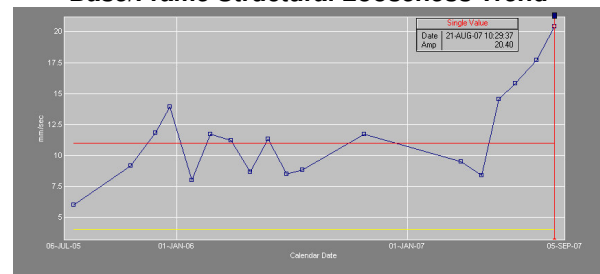
2 05
Base/Frame Structural Looseness Trend

There has also been a steady increase in structural looseness vibration caused by looseness of the frame/base to the floor. (See motor trend 2 05).

There has been an increase on the pump bearings, due to stress caused by the increased vibration from the structural looseness.

Although the base/frame has been concreted in, it is still structurally loose and the vibration level is now above acceptable limits. Is the new concrete base secure to the original floor? Visual inspections indicate the base/frame has worn loose within the new concrete base. I would recommend the base/frame is secured as soon as possible.

Carry out the base/frame security repairs before irreversible damage is caused to the pump bearings.

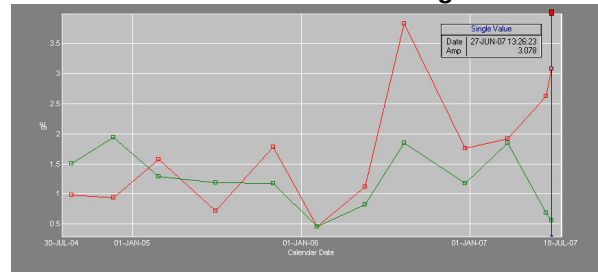
2 02
Motor Drive End Bearing Trends
Red = Left Motor Green = Right Motor

The left motor is maintaining a steady increase in wear fault frequencies from the drive end bearing. (See left & right motor drive end bearing trend overlays 2 02).

Change the bearings when production allows.

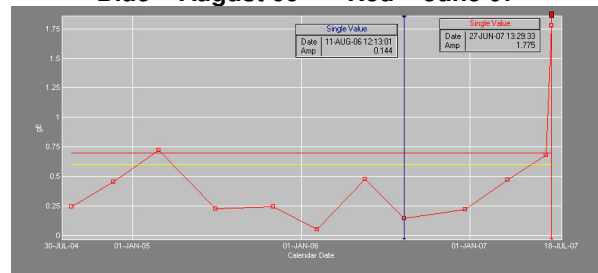
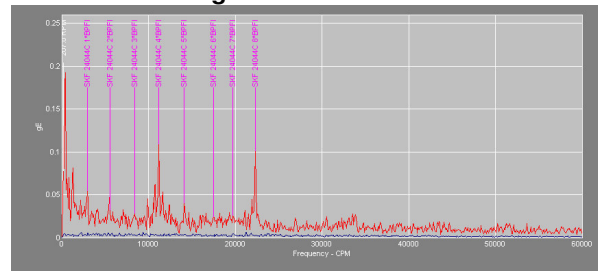
The press has shown a large increase in the previously reported bearing frequencies. This is due to the progression of a bearing fault on the rotor shaft. (See press shaft trend and spectrum overlay 1 02). The press shaft trend and spectrum overlay 1 02 opposite, shows the difference between when it was fitted in August 06 (Blue trace) and it's last reading on 27 June 07. (Red trace).

As both press shaft bearings are the same size and only checked from one point, it is not possible to identify which bearing is faulty.

There is also looseness/movement vibration on this shaft.

I would recommend the press shaft bearings are changed urgently. Also whilst dismantled inspect the press assembly for wear.

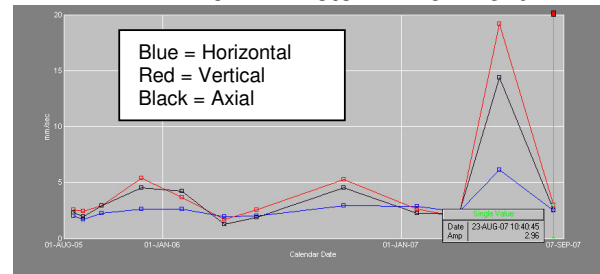
2H.1: 2V.1 & 2A.1 Motor DE Vel. Trend

Satisfactory. See below.

Replacement of intermediate shaft bearings, alignment of belt pulleys and alignment across the fluid drive has reduced general vibration and bearing distress levels considerably as illustrated on attached trends.

Routine monitoring.
