Thumb Injury on Raft 8

A maintenance contractor sustained a serious thumb injury after striking it with a 4lb copper hammer while attempting to release a locking pin during crane maintenance work on Raft 8.

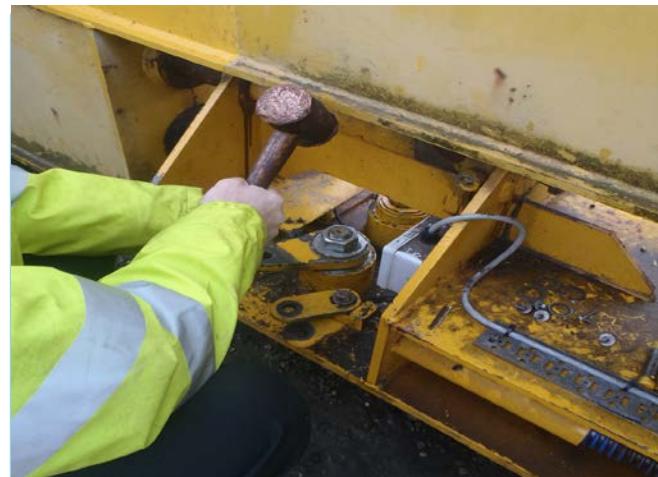
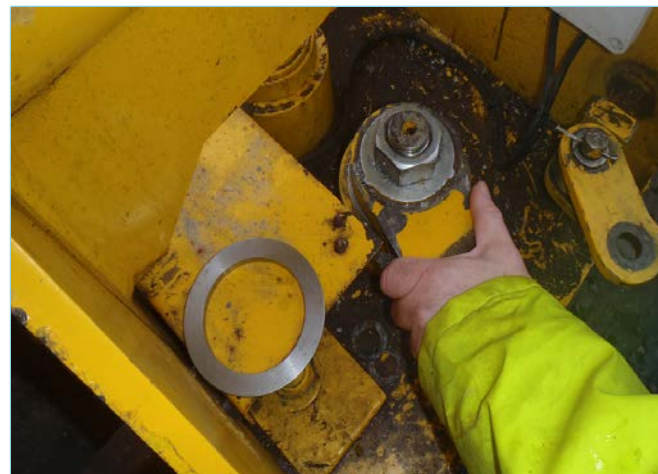
The pictures on the right show what is believed to be the hand position of the contractor – note he was wearing protective gloves at the time of the accident.

Crane maintenance work is covered by a JSA and the contractors' risk assessment/method statement, HOWEVER, this documentation did not cover the hazards associated with the use of hand tools.

In hindsight, this work could have been conducted in a safer manner e.g. using a puller or by supporting the plates using a mole wrench.

Always conduct a Prepare & Prevent prior to starting work, particularly for infrequent tasks.

Does the JSA or Risk Assessment/Method Statement cover the activity to be carried out? Is there a safer method of doing the work? If in doubt, STOP and seek advice on the next step.
