Fireball from Aluminum Grinding Dust

Fatal Grinder Accident at Quarry

Firm fined for grinder accident

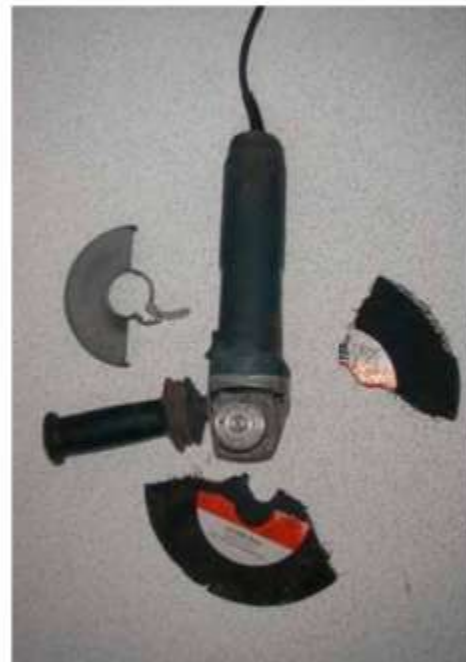
A welder was carrying out maintenance on a quarry excavator bucket. He was using an angle grinder to prepare surfaces for welding when the disk disintegrated.

The hand-held angle grinder was fitted with a 230 mm diameter cutting-off wheel and when it disintegrated, fragments penetrated the victim's chest and abdomen. He was rushed to hospital by rescue helicopter but died the same day.

This is continuing but initial inspections show that the grinding machine and cutting disk were not compatible - and the grinder was not fitted with a guard.

Angle grinder and disintegrated disk

Grinding machines and abrasive wheels should always be used in accordance with the manufacturer's instructions.

- Always ensure the maximum speed (the no load rpm) marked on the abrasive wheel is greater than the rated speed of the grinder.
- Do not use grinding wheels that are larger than the maximum recommended size, or worn down wheels from other grinders.

- Never use grinding wheel power tools without the wheel guard attached to the tool and positioned for maximum safety.
- Store and handle abrasive wheels with care and inspect them for chips or cracks before installing. Do not use any wheel that may be damaged.
- Refer to Australian Standard 1788 - *Abrasive Wheels* for more detail.
